ADDRESSING VARNISH PROBLEMS

BALANCED CHARGE AGGLOMERATION RESULTS IN 50,000 HOURS OF LUBE OIL OPERATION ON GE FRAME 7 TURBINES

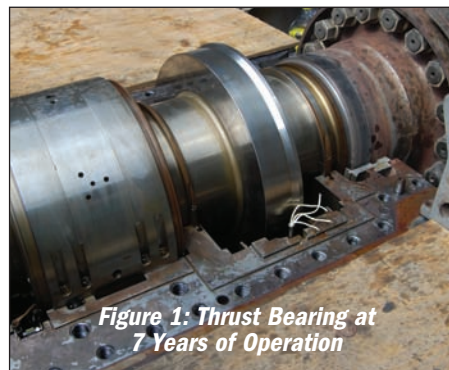
Figure 1: Thrust Bearing at 7 Years of Operation

In 2009, the thrust bearing on one unit was opened for inspection. The internal surfaces of the bearings, seals and thrust bearing components were all found to be free of varnish buildup (Figures 1 & 2). By comparison, a unit in another plant with no purification system was covered with a heavy orange varnish buildup after four years of operation.

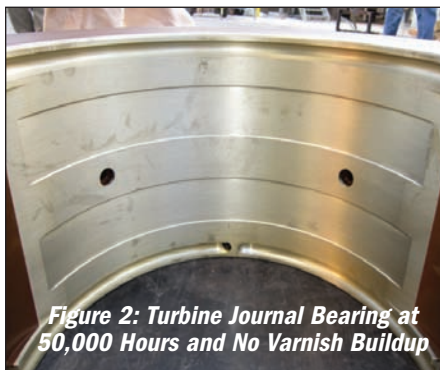
Figure 2: Turbine Journal Bearing at 50,000 Hours and No Varnish Buildup

These turbines recently completed their first tear down. The journal bearings showed no wear and no varnish buildup. The tanks, however, did have a small patch
